INVESTIGATION NO. 3028  
NORTHWESTERN PACIFIC RAILROAD COMPANY  
REPORT IN RE ACCIDENT  
NEAR DOS RIOS, CALIF., ON  
SEPTEMBER 30, 1946

Kind of accident: Head-end collision

INVESTIGATION NO. 3028

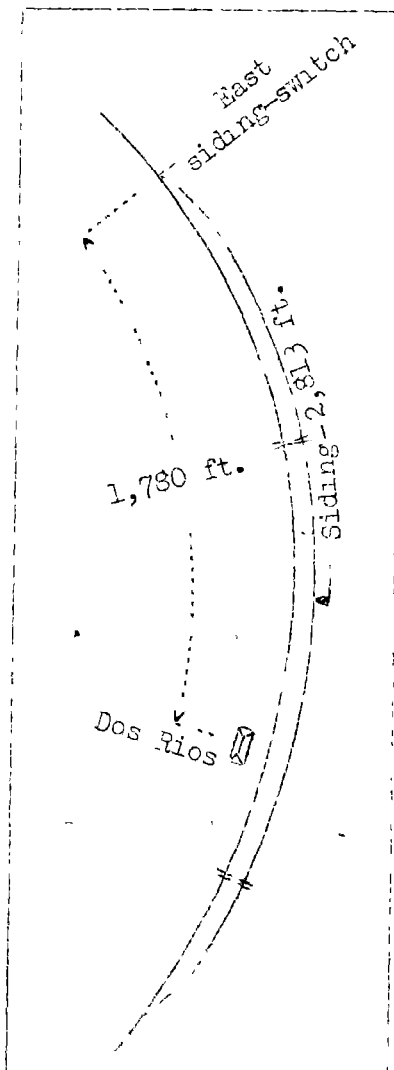
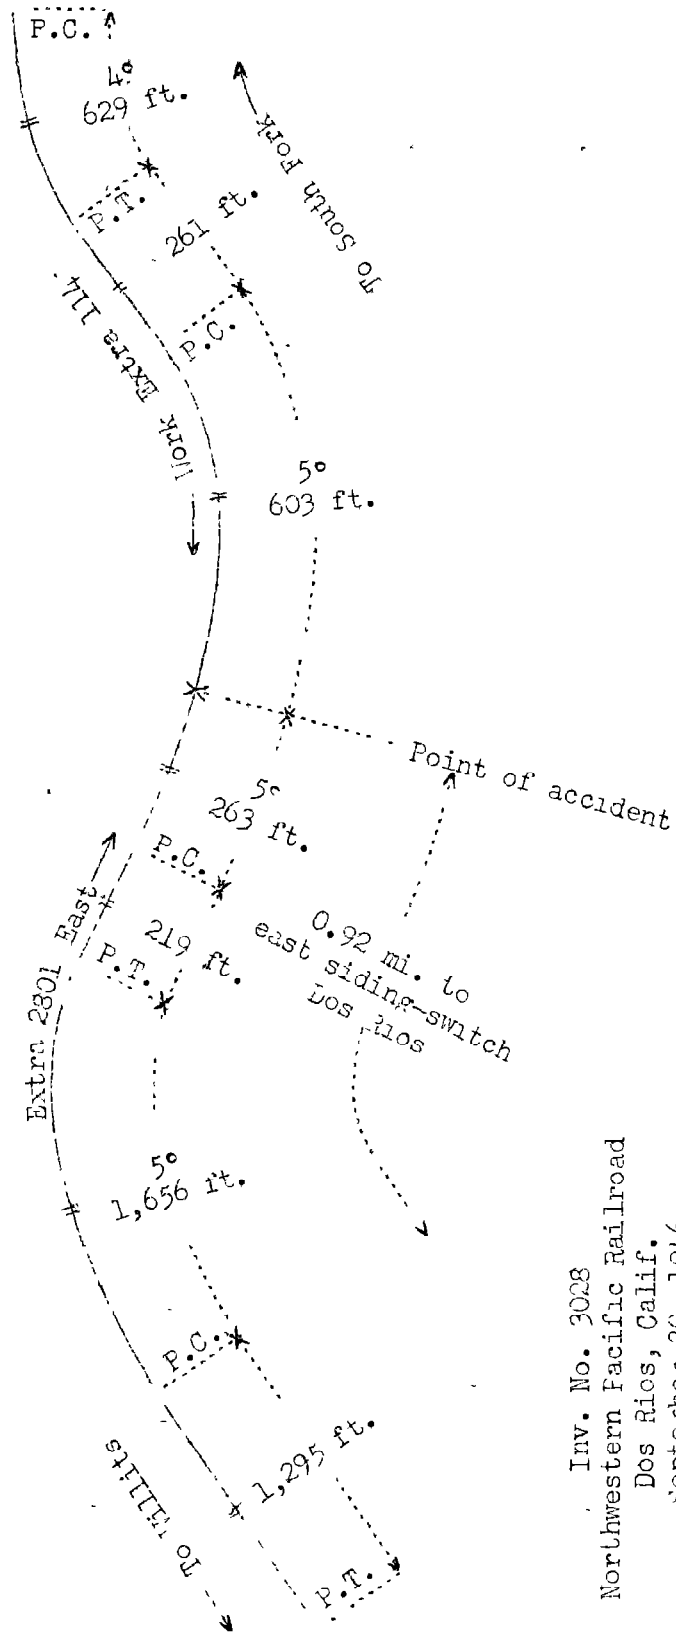
Inv. No. 3028  
 Northwestern Pacific Railroad  
 Dos Rios, Calif.  
 September 30, 1946

- o South Fork, Calif. 28.2 mi.
- o Alderpoint 33.6 mi.
- o Nashmead 7.7 mi.
- X Point of accident 1.3 mi.
- o Dos Rios 27.0 mi.
- o Willits, Calif.
